## Case Report

# Fractures of Cementless Thin-Walled Cups

**Abstract:** Cementless threaded cups are commonly used in total hip arthroplasty. A method to match the elasticity of the cup to that of natural bone is reducing the wall thickness of the implant. Despite good results with this philosophy of implantation, we recently observed 3 cases of implant fractures after the implantation of such thin-walled cups called “Bicon.” We performed a thorough analysis of 1 of these cases including a histological examination and a technical failure analysis (including scanning electron microscopy) to establish the chronology and cause of the failure. Multiple fractures of the thin-walled metal-back cup were determined to be caused by fatigue. We have concluded that due to the specific material and design parameters of this cup, under adverse circumstances such as the lack of primary or secondary osteointegration, there is a risk of failure due to fatigue. **Key words:** total hip arthroplasty, threaded cups, implant failure.

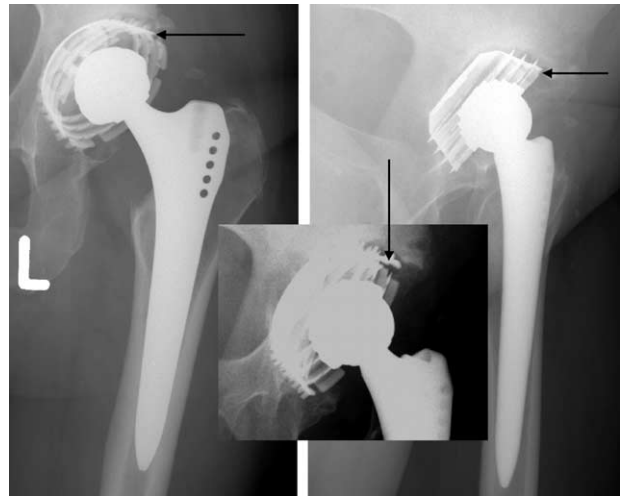
**Fig. 3.** X-ray 6 years postoperative with a fine fracture line in the cranialateral part of the cup, best seen in the axial view and radiolucent lines in the bone-implant interface in zones I and II.

et al [10]) which had not been visible in previous years. An exact tangential radiograph of the acetabulum revealed a fine hardly noticeable fracture line in the implant (Fig. 3). In June 2001, revision surgery was performed, and it was discovered that the cup had fractured into 3 fragments. There were no signs of impingement at the stem's neck or at the corresponding rim of the metal insert. The insert was intact and not dislocated.

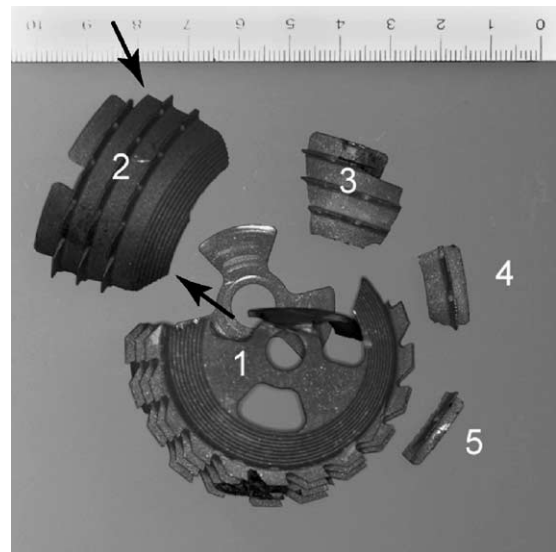
**Fig. 4.** Macroscopic overview of the cup fractured into 5 fragments. Fragments 1, 2, and 3 due to fatigue, fragments 4 and 5 generated during revision surgery.

Failure analysis of the cup revealed multiple fractures with a hemicircular crack in the polar area and several radial cracks starting at the grooves for the insertion device (Fig. 4). The cup was broken into 5 fragments; however, 2 of these fragments had been created during the revision operation by the extraction of the implant.

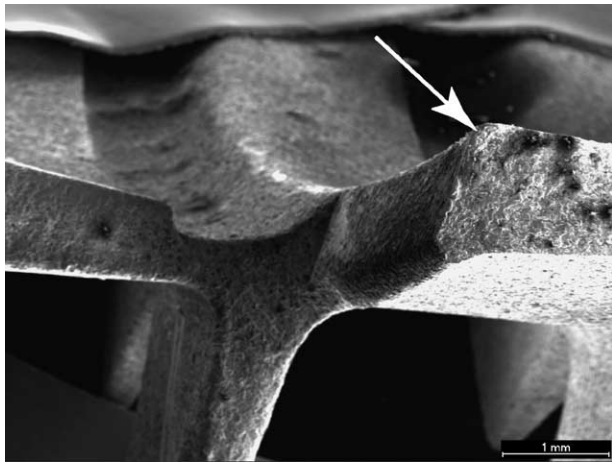
**Fig. 5.** SEM image (magnification  $\times 25$ ) of fragment 2. The arrow marks the origin of a crack at 1 of the notches for the insertion instrument (region of the upper arrow in Fig. 4).

no proof of flawed manufacturing or improper implantation. Using SEM, the origin of cracks and the type of fracture (fatigue vs forced rupture) could be analyzed. On fragment 2 (Fig. 4), there were 2 regions where cracks had developed independently of each other (see arrows in Fig. 4). One crack started at 1 of the notches for the insertion instrument (Fig. 5). The other crack began near the polar region from 1 of the 3 holes and later branched out into 2 flaws (Fig. 6).

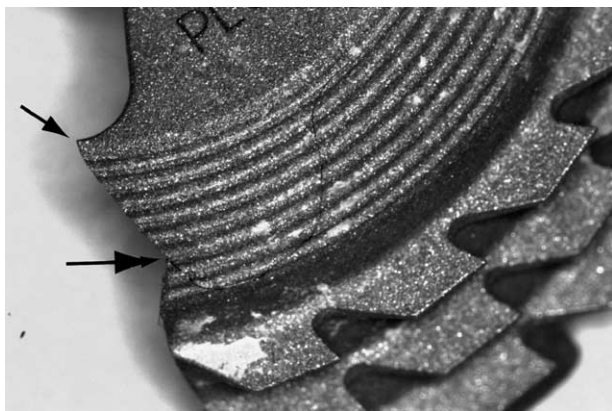
**Fig. 6.** Macroscopic view of the polar region of fragment 1. Crack origin marked with arrow; later, the crack branched out into 2 flaws (double arrows).

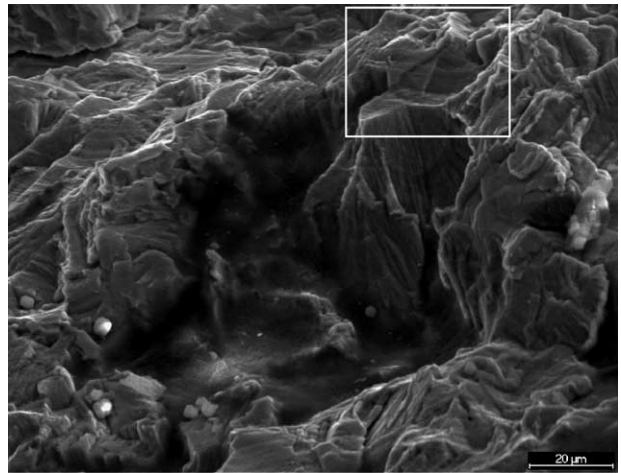
**Fig. 7.** SEM image (magnification  $\times 800$ ) of the fracture surface at the polar region of fragment 2 (lower arrow in Fig. 4).

The fact that there were multiple origins for the cracks proves that the implant was generally overloaded. All cracks developed sequentially. A forced rupture due to the patient's traumatic fall could be excluded as the cause by the presence of so-called striations. Fig. 7 displays the fracture surface of fragment 2 at the polar region. At high magnification, the striations, which are typical of fatigue failure, are recognizable (Fig. 8).

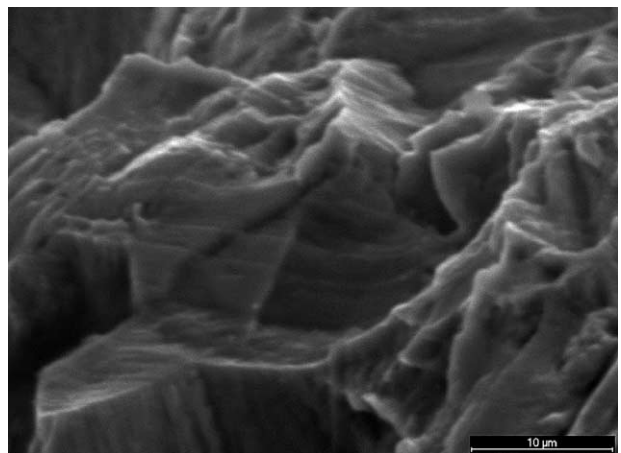
**Fig. 8.** SEM detail of Fig. 6 (magnification  $\times 3000$ ) showing fracture surface with striations (marked rectangle in Fig. 6).

Failure analysis of the cup revealed that the multiple fractures were due to fatigue. Therefore, although this patient had fallen onto the hip, the failure of the implant was not the result of this trauma. The primary cause for failure was general overloading of the implant. Multiple cracks developed from regions of high mechanical loading and stress concentrations, for example, the notches for the insertion instrument and holes in the polar region. The coarsely blasted outer surface of this thin-walled implant made of pure titanium was a further factor that led to failure because of the notching sensitivity of this material. SEM investigation proved that the cracks increased slowly by cyclic loading of the patient. The location of the crack origins corresponded on one hand with the hoop and bending stress within the cup and, on the other hand, with the design of the shell with its equatorial grooves and polar perforations.
