## Case Report

# Fractures of Cementless Thin-Walled Cups

**Abstract:** Cementless threaded cups are commonly used in total hip arthroplasty. A method to match the elasticity of the cup to that of natural bone is reducing the wall thickness of the implant. Despite good results with this philosophy of implantation, we recently observed 3 cases of implant fractures after the implantation of such thin-walled cups called “Bicon.” We performed a thorough analysis of 1 of these cases including a histological examination and a technical failure analysis (including scanning electron microscopy) to establish the chronology and cause of the failure. Multiple fractures of the thin-walled metal-back cup were determined to be caused by fatigue. We have concluded that due to the specific material and design parameters of this cup, under adverse circumstances such as the lack of primary or secondary osteointegration, there is a risk of failure due to fatigue. **Key words:** total hip arthroplasty, threaded cups, implant failure.

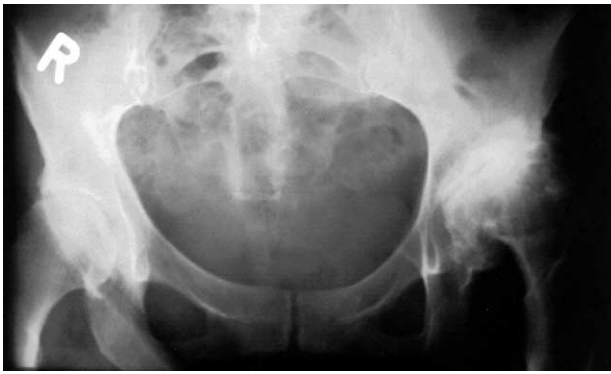
**Fig. 1.** Preoperative radiograph with dysplastic coxarthrosis type 2 according to Crowe on the left side.

motion and a leg length discrepancy of 2 cm, underwent primary total hip arthroplasty. She weighed 70 kg and had a body mass index of  $26 \text{ m}^2/\text{kg}$  (Fig. 1).

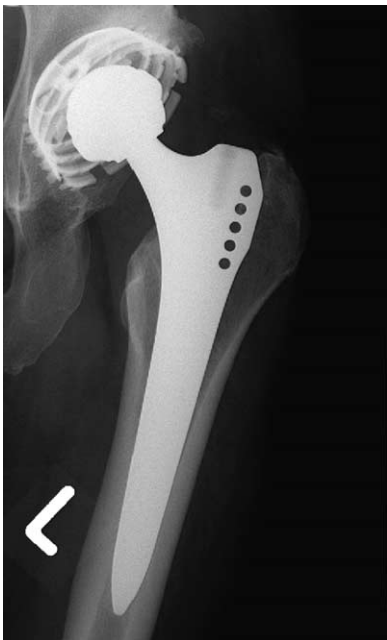
A Bicon cup (Plus Endoprothetik AG) with the following measurements was implanted: size 5 (outer diameter 56, inner diameter 53, wall thickness 1.5 mm), a Sikomet metal-on-metal bearing (sandwich liner with polyethylene between the cup and the metallic bearing part) (Sikov Medizintechnik GmbH, Vienna, Austria), and an “SL” straight tapered stem (Fig. 2).

**Fig. 2.** Total hip arthroplasty 3 days postoperative.
